MNPV6 Disco swap out

This grid tie house in Hawaii had a code compliant and inspected pull switch for the required exterior AC disconnect. The following pictures show the pull switch installed and then replaced with a MidNite Solar disconnect. The MidNite disconnect could also have had the PV array disconnect in the same enclosure although on this installation only the 240VAC disconnect was used.

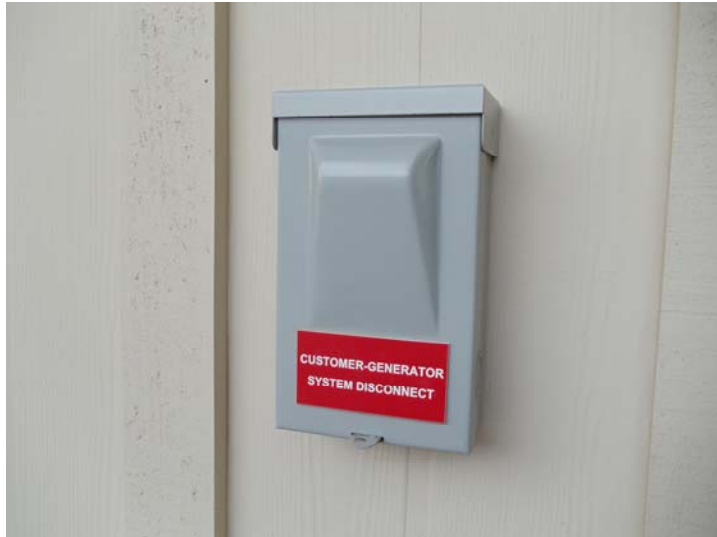
Figure 1 Square D pull switch. Works fine, just not what the customer wanted.

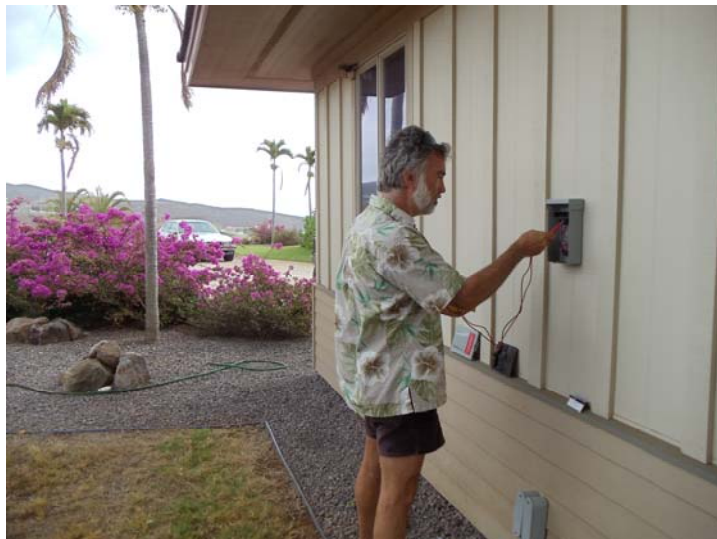
Figure 2 Tom checking to make sure the power is off.

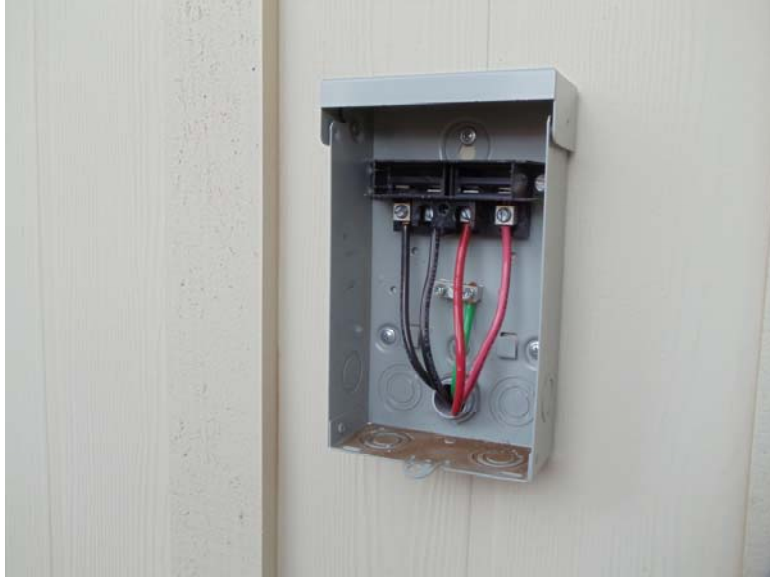
Figure 3 Square D pull switch wiring. The shorting bar has been removed. Leg1 in and out on the left (black) and leg2 in and out on the right (red). The shorting bar (pull bar) has two pieces of brass that connect the ins and outs together when installed. This meets code, but is not very handy. You must first unscrew the cover, then pull real hard to get the switch disconnected. Not what you would want to go through in an emergency.

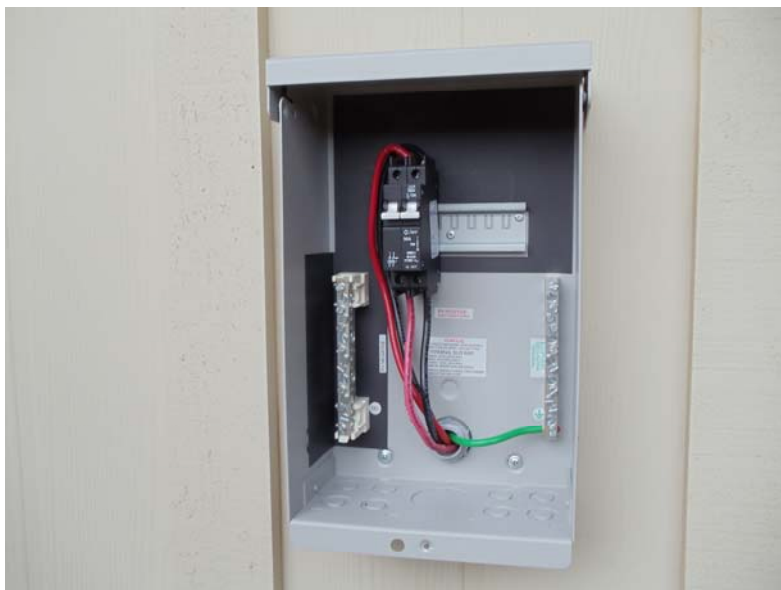
Figure 4 The Midnite MNPV6 Disco enclosure installed in place of the pull switch. A 2 pole 30 amp AC breaker is installed in the enclosure (MNEAC30-2P). The Neutral busbar is not used in this installation.

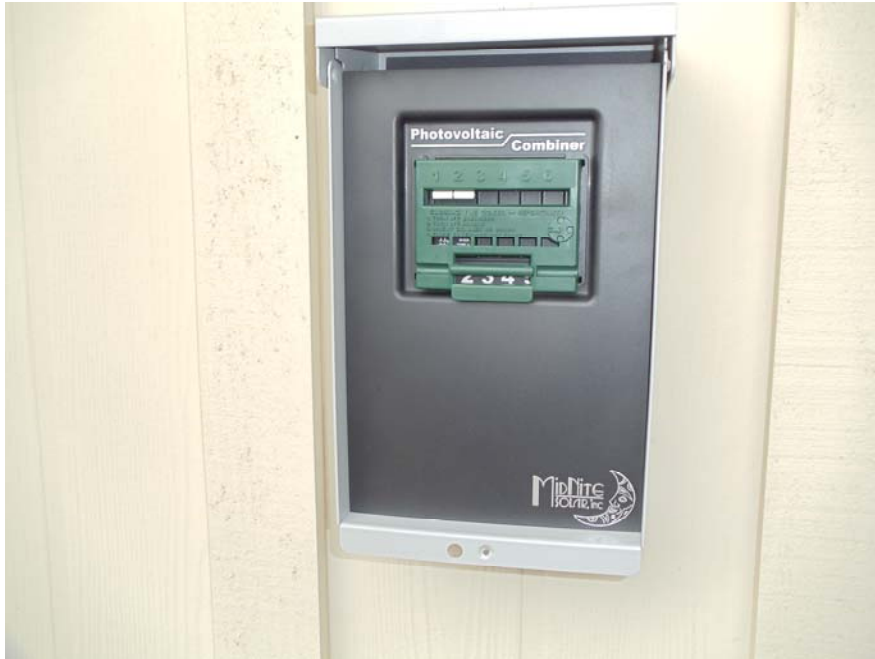
Figure 5 The black Deadfront with its integral green slider is snapped into place. Note breaker handles sticking through the slot at the top end on the slider. The green slider moves up and down based on exterior handle movement. This up and down action turns the breakers on and off. There is room for up to 6 breakers total. The MNPV6 Disco is ETL listed for 240VAC and 600VDC breakers in the same box. A 600VDC breaker will take up four more slots.

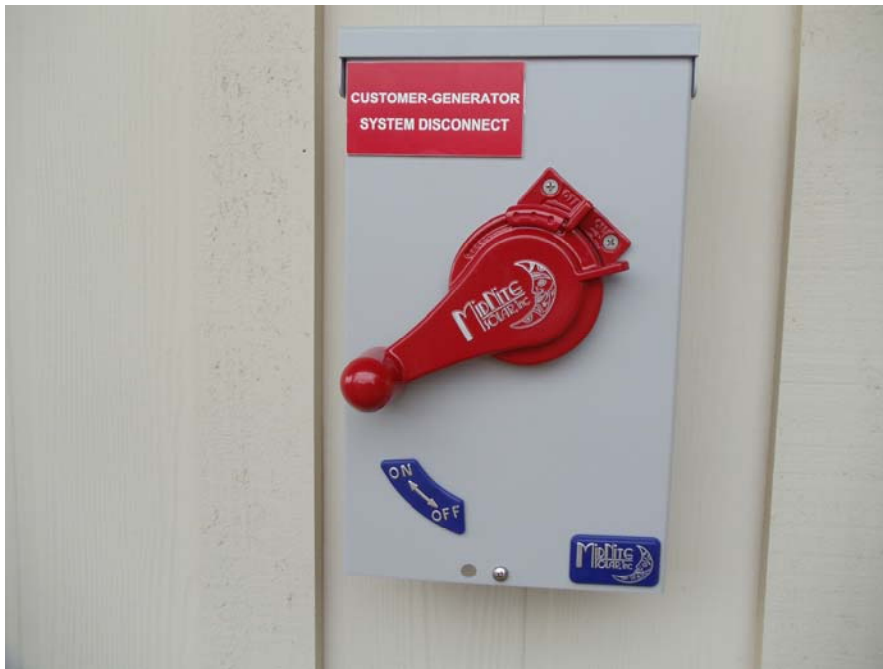
Figure 6 The cover/handle assembly installed with disconnect plaque reinstalled onto the new MidNite disconnect.

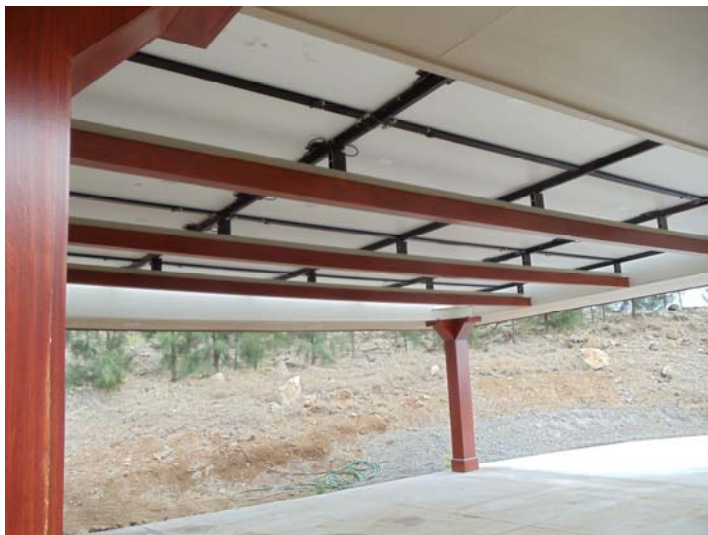
Figure 8 Underside of the 5000 watt array. The customer wished for a carport style array where the solar panels do not show. This reduces output and requires additional module cleaning.
